## Chlorine Transfer Hose Failure

August 2004

## Make Sure What You Install is Adequate for the Service

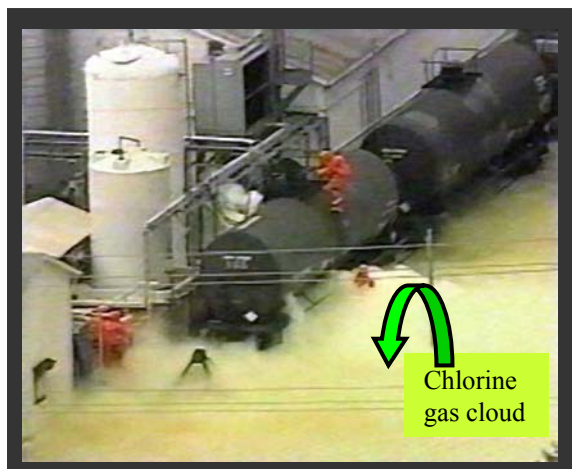
Hastelloy (left) and stainless steel hoses appear identical.

- ? The ruptured hose should have had an inner Teflon liner reinforced with a Hastelloy C-276 exterior metal braiding. Instead, the exterior metal support braiding was stainless steel and was easily corroded by chlorine permeation through the Teflon liner. The hose failed after less than 2 months of service.
- ? Both the purchase and shipping papers indicated that the hose was constructed of the proper materials, but it was not tested or verified upon receipt.
- ? An emergency shut down system activated by an employee before evacuation failed to work because of severe build up on the valve ball.

- ✓ Know what to do in an emergency! Always check to ensure that emergency shutdown equipment has a current test tag. If it does not, report it. Test the entire shut down loop before you rely on it. Your job—make sure it will work when needed!
- ✓ Conduct a pre-use check before using any replaceable equipment, such as hoses, sample containers, instruments, etc. to be sure that they are fit for the service. If in doubt—do not use it!
- ✓ When receiving new equipment make sure that it is exactly what was ordered. Some materials are difficult to tell from others, but performance may be significantly different!
- ✓ Ask for "positive materials identification" testing where different materials look alike. This is especially important where a mix-up can lead to a hazardous event. Make this part of the area's process hazards analysis.
