A "GOOD IDEA" CAN TURN BAD . . .

**WHEN YOU IGNORE MANAGEMENT OF CHANGE!****Here's What Happened:**

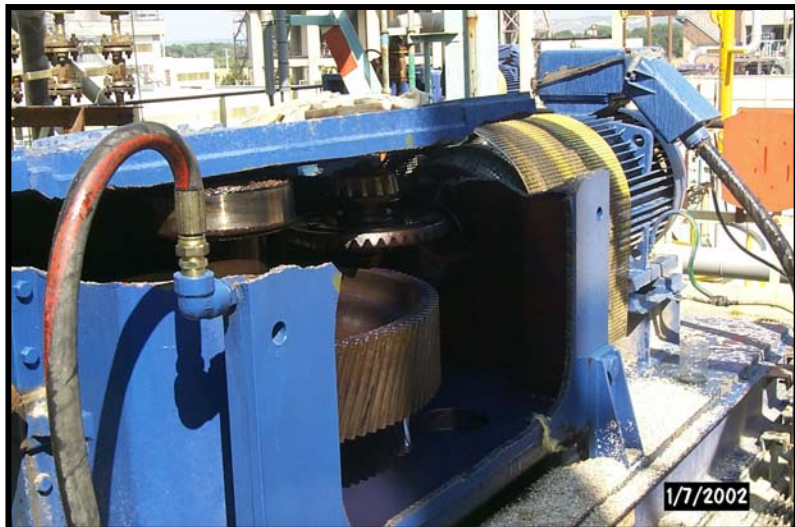
A mechanic was draining oil from this large gear box. The oil was draining out **very** slowly, so he decided to speed the job up by connecting an air hose to push the oil out faster. It didn't take long for the results shown to happen. The cast iron gear box fractured, blowing a large piece off and onto the floor. Fortunately, no one was hurt.

- The gear box was not a pressure vessel
- More air was added than could be vented, so the pressure built up
- MOC was not used to review the change

- Many pieces of equipment in a chemical plant are NOT designed for pressure. Check the equipment folder, but if there is no ASME code stamp, assume that it is not pressure rated.
- Adding air to the gear box was a change and should have been checked through the site's MOC process.
- Be alert to subtle changes that might not be safe.

Good ideas improve operations and reduce risk every day. However, before implementing a good idea, it is essential to review the change to ensure that it doesn't introduce any new hazards or risks to the workplace. In this incident, the mechanic should have recognized what he was about to do as "not like-in-kind" and reviewed the change through the MOC process. This would have identified that the gear box was not designed for pressure.
